Scope of Service

Background

The subject structure is a 5500 Square feet dwelling 3 bed, 4.5 bath single family dwelling built in 1960. The initial purpose of the inspection was to inspect for hail damage on the exterior of the home after AllState Insurance performed an initial inspection on September 1, 2020.

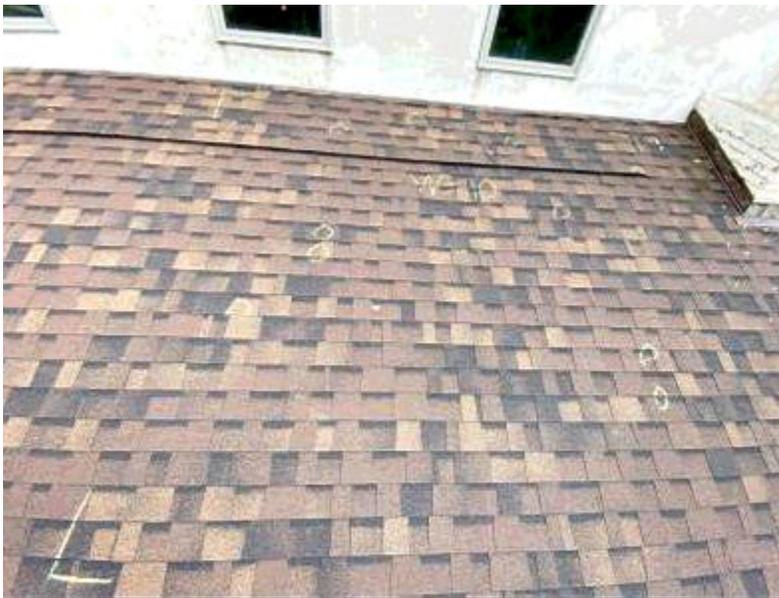
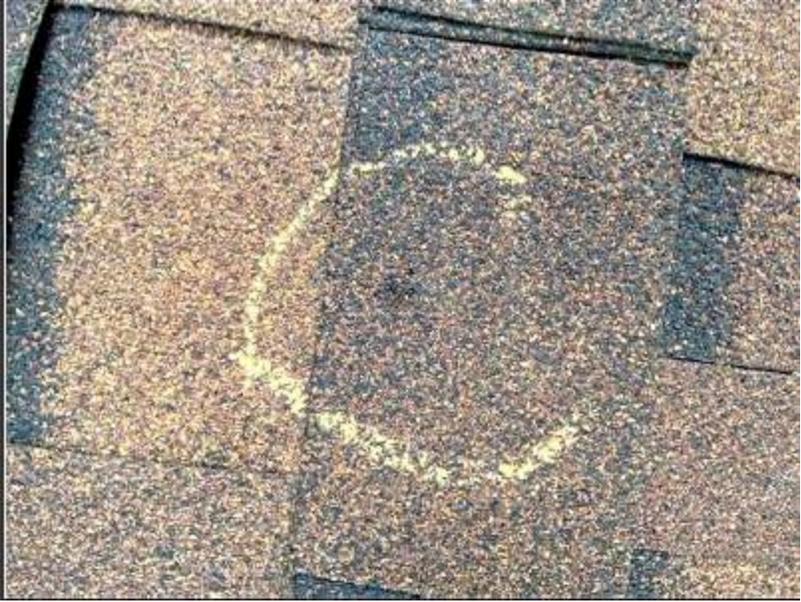
The exterior inspection began with the back roof validating hail damage per the report provided by AllState Insurance and approved for replacement. Several shingles were damaged and the entire back roof is in need of replacement. Continuing our roof inspection we moved to the front of the roof which was denied and found more the

8 hail hits in a 10x10 sample size and all second story windows have damage on the front elevation. Further investigation verified damage to the roof eave copper gutters as well as the downspouts.

1. The front roof has hail damage and needs replacement
2. 20 windows has hail damage
3. 1 door has hail damage
4. Both exterior decks have hail damage.

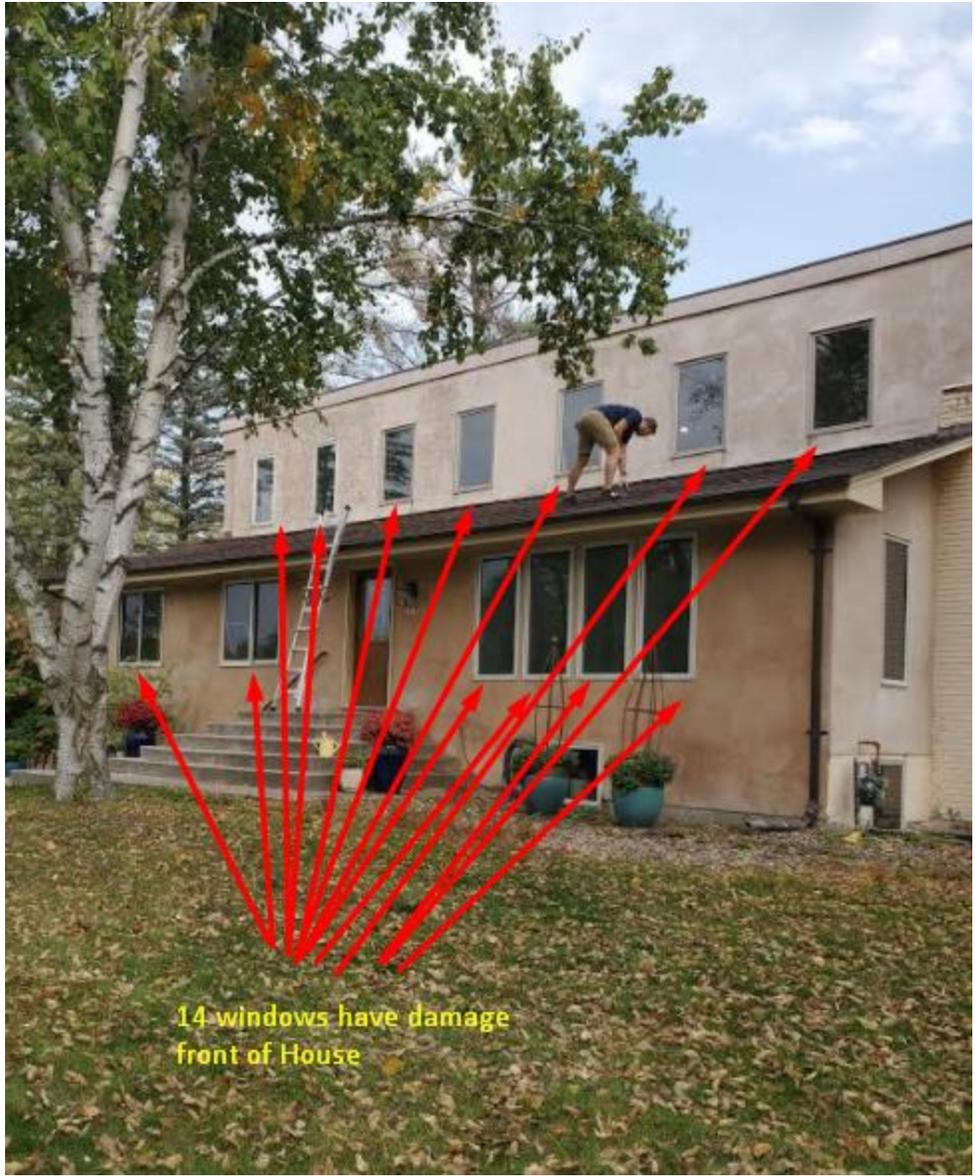
14 windows have damage front of House

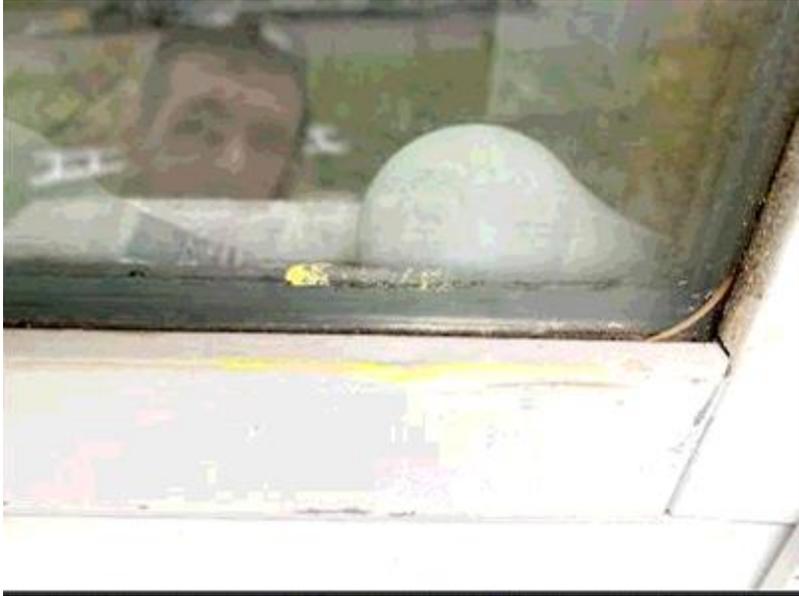
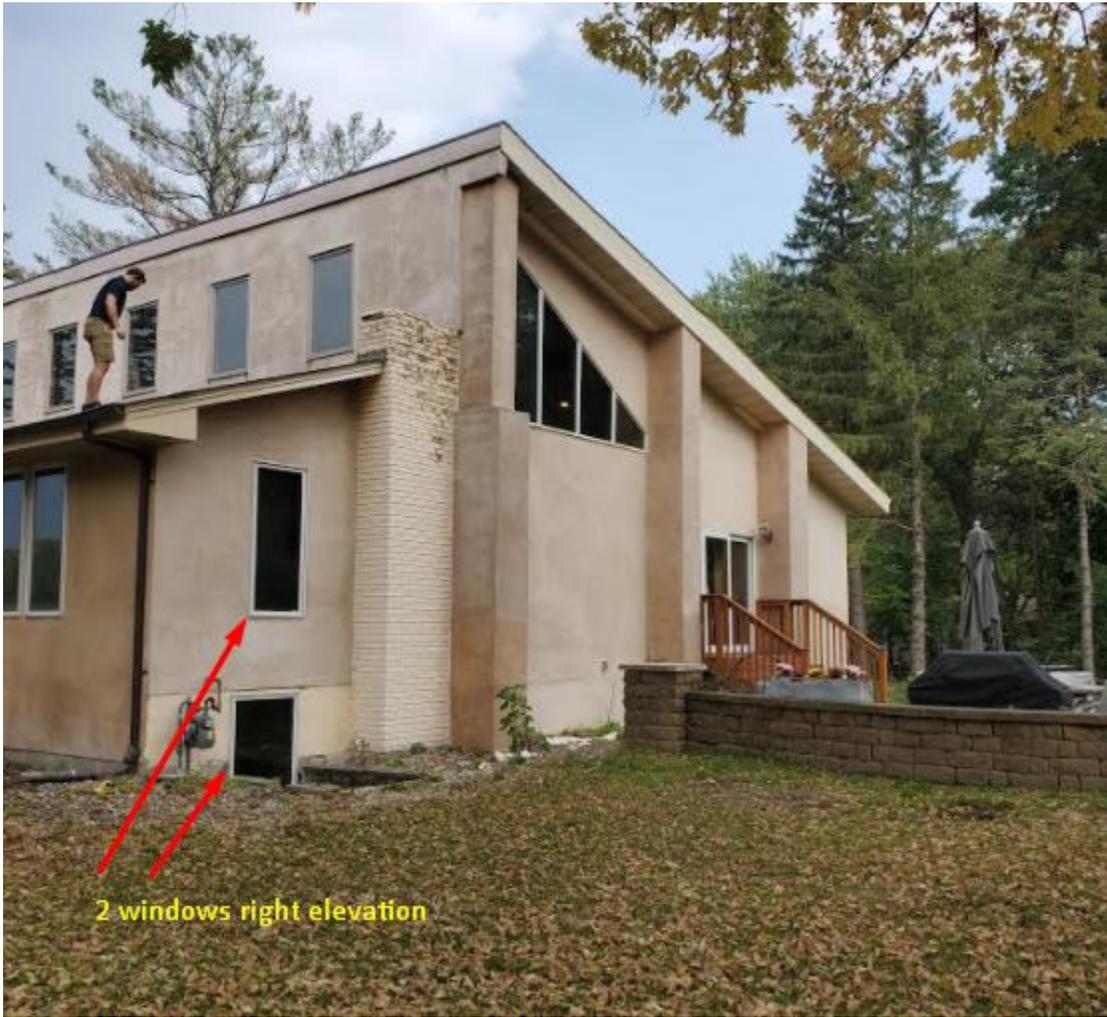
2 windows right elevation

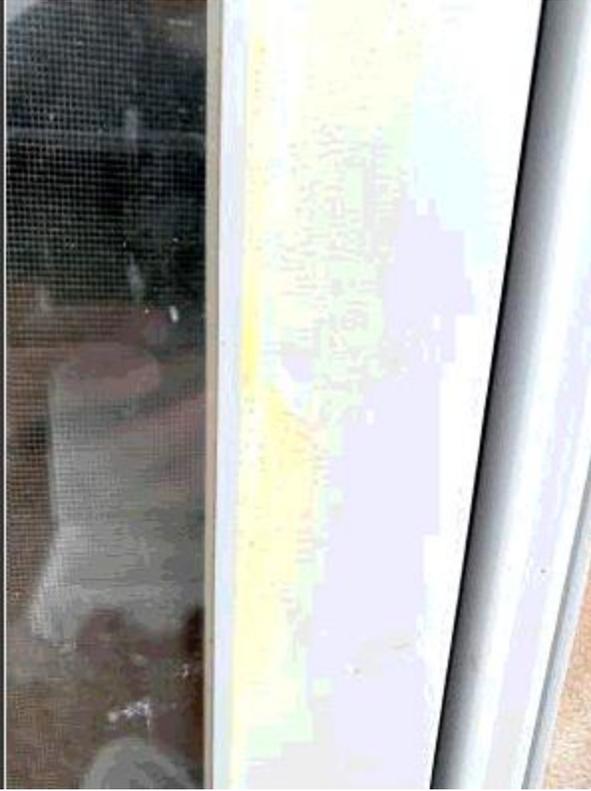
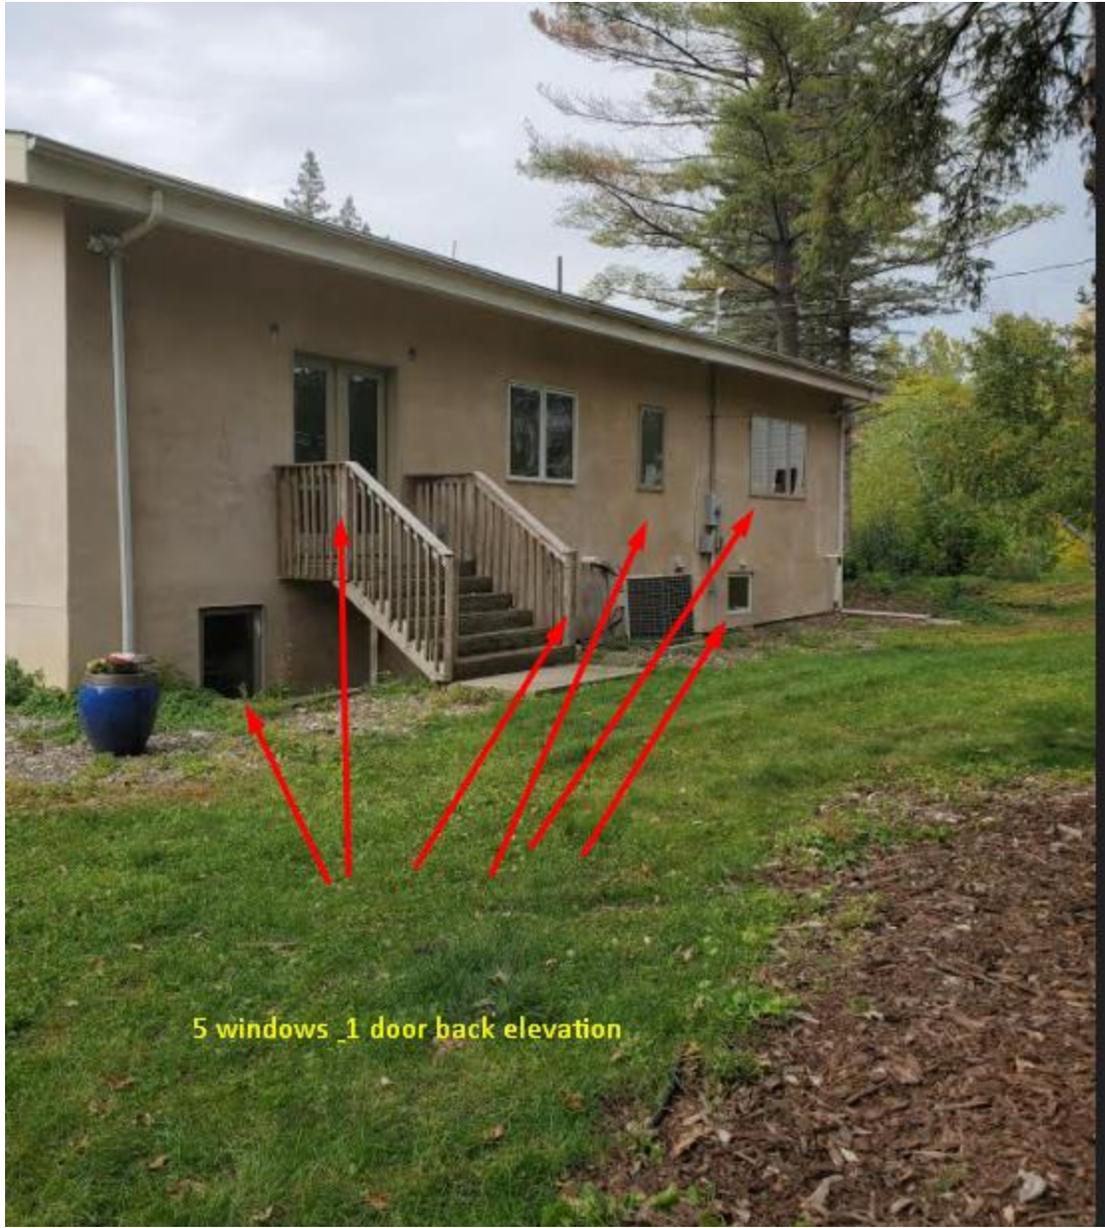
5 windows _1 door back elevation
